**North Slope of Alaska ARM Facilities
Monthly Status Update
Sandia National Labs**

February 2018

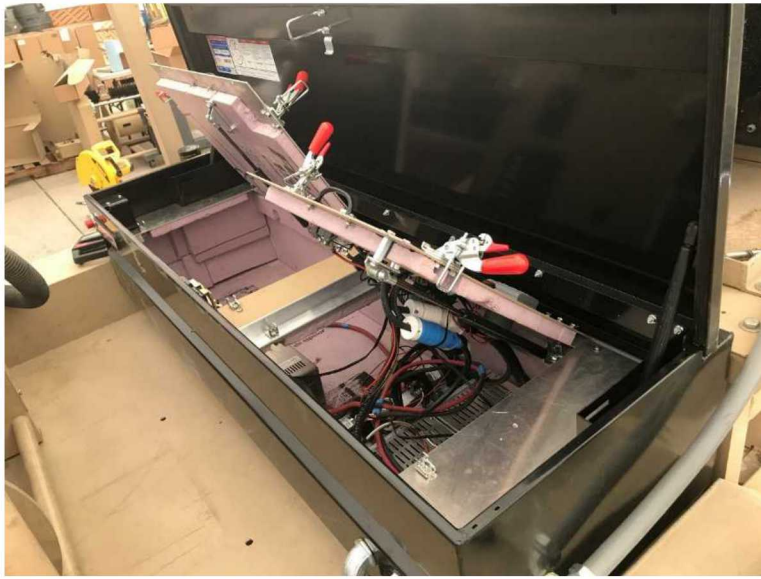
Figure 1: Electronics enclosure with gas shocks and latches installed.

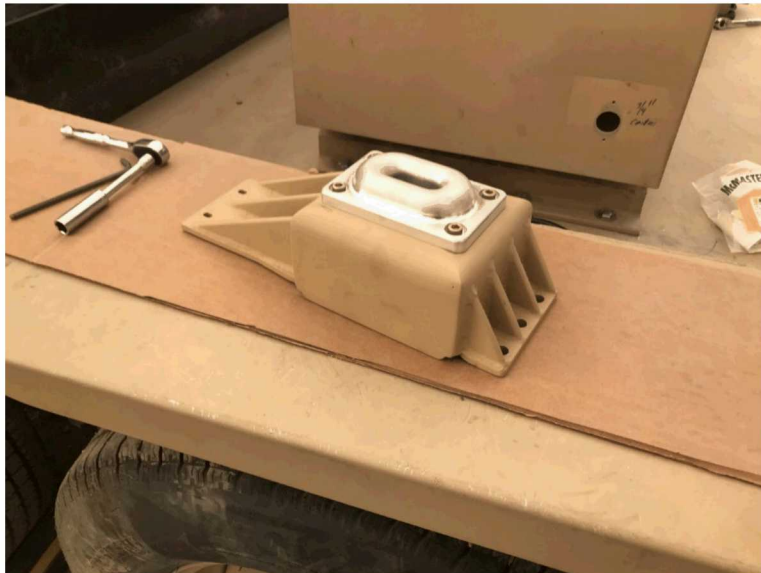
Figure 2: Levelwind bracket after painting. Grade 9 hardware was used to withstand up to 6000 lbf side load.

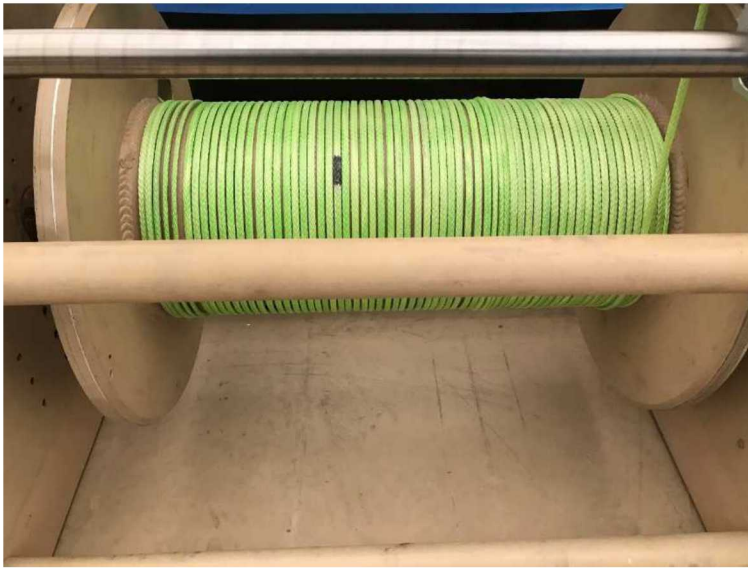
Figure 3: With new gear reduction levelwind lays tether with minimal overlap. In turn, this save space on the drum to allow for a longer length of tether to be used, and for the balloon to potentially be flown to higher altitudes.

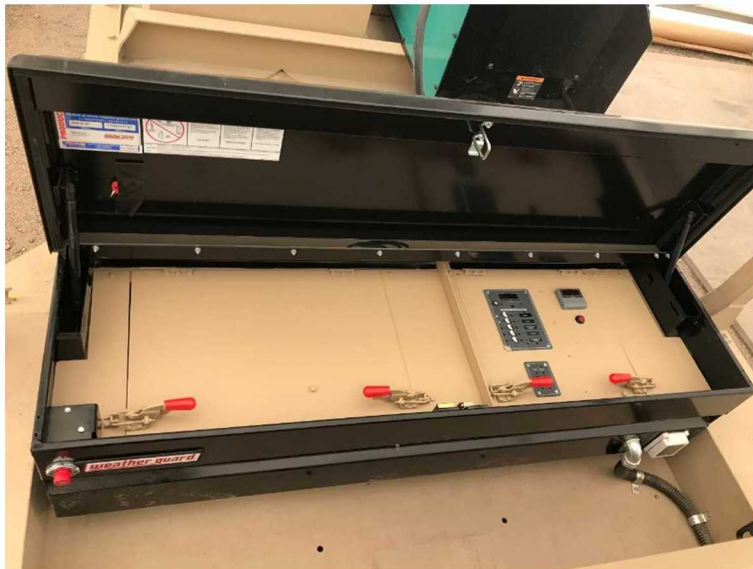
Figure 4: Electronics enclosure with new panels painted to match rest of the trailer.

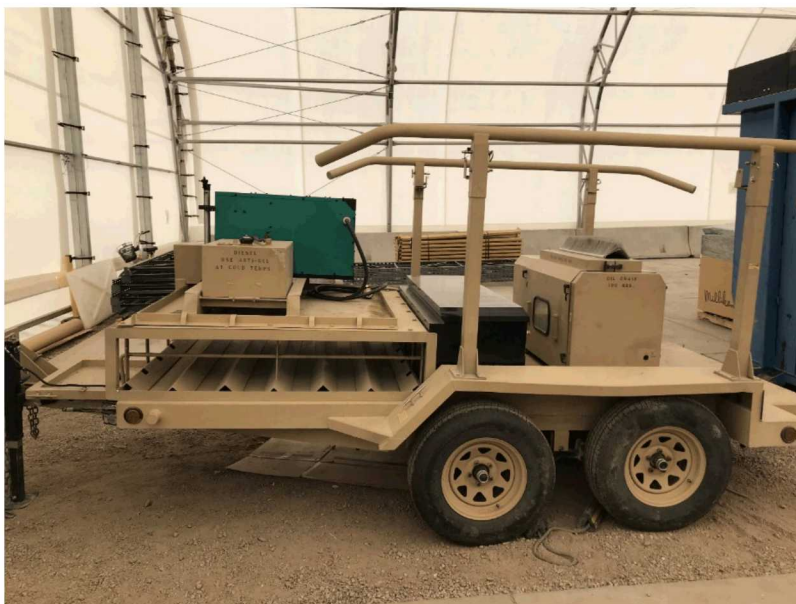
Figure 5: Current set up of the Oliktok TBS trailer. Arms have been shortened to prevent any entanglement with the tether during flight.

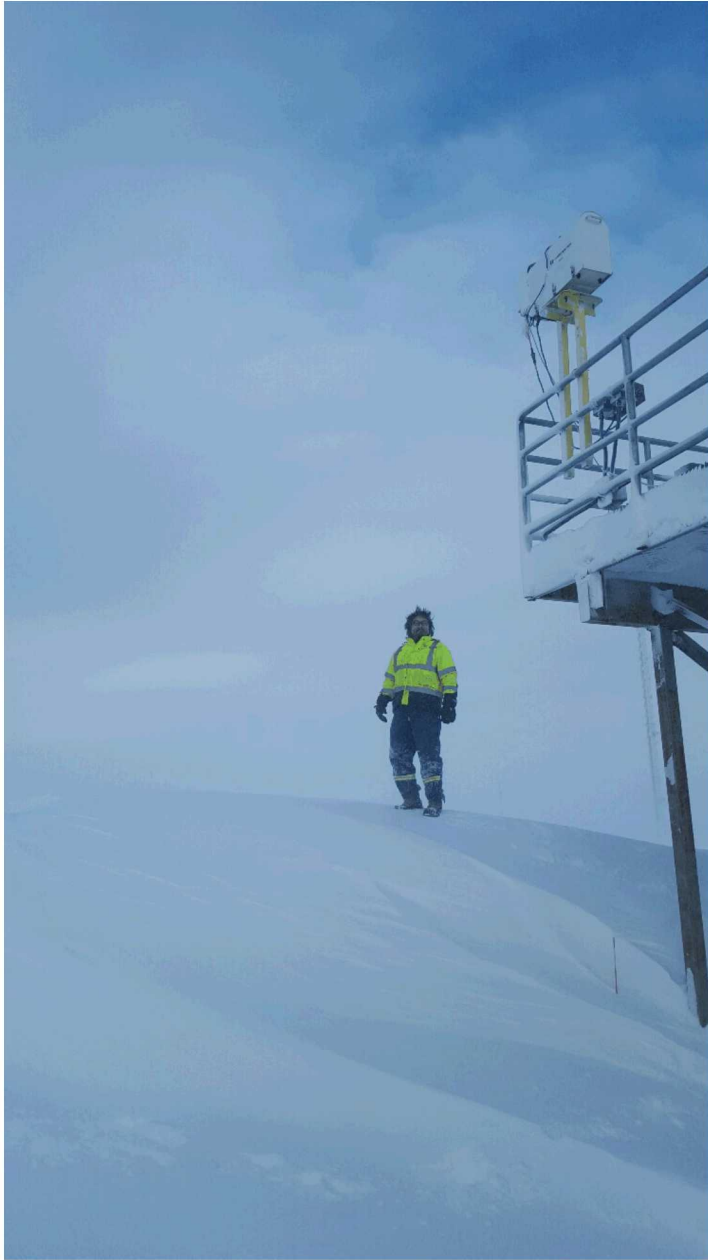
Josh standing on 8ft snowdrift where site access road is located.

Winter winds and snowfall have been above average this year. At times, the site has only been accessible by Kubota or Polaris with tracks.
